**الهدسة الوطنية العليا للتكنولوجيا و الهندسة - عنابة**  
**National Higher School of Technology and Engineering – Annaba**

for the  
MASTER DEGREE

**Diagnosis and Repair of Workshop Electro-Mechanical Systems**

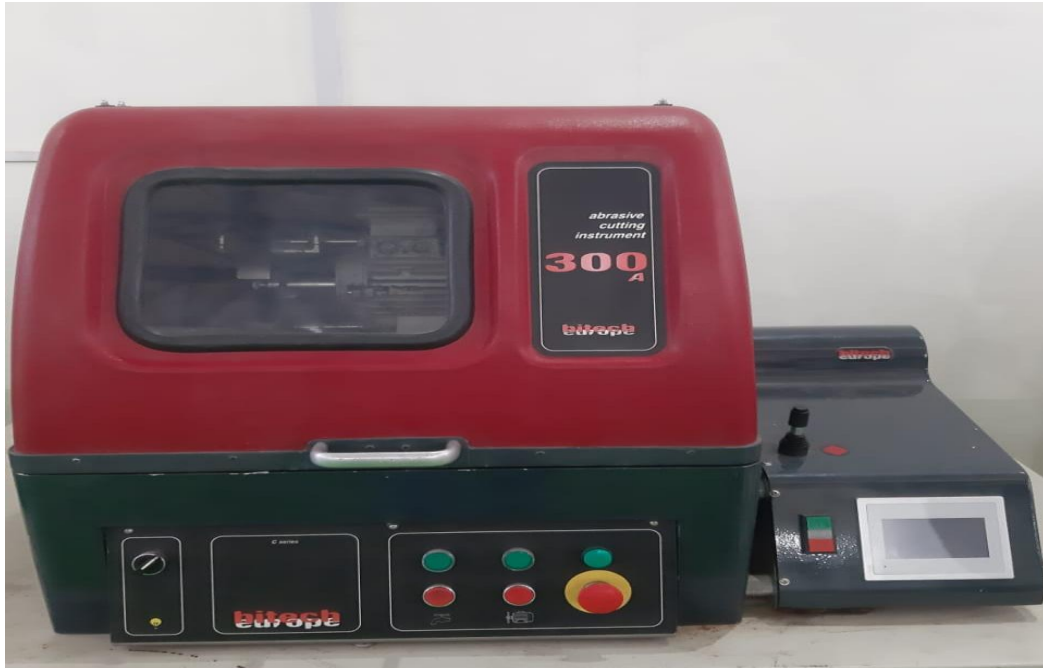
Figure 3. 1: The Hitech Europe 300 A Macro Cut-Off Saw

Upon attempting to operate the machine, it was observed that it did not respond to commands input via the HMI, specifically for initiating the movement of the cutting wheel assembly. Furthermore, the main drive motor would operate briefly after startup but would then shut down and could not be restarted without a full power cycle (restarting) of the entire machine. These symptoms indicated a significant operational fault requiring systematic diagnosis.

A general visual inspection of the machine exterior indicated it was clean, with no immediate signs of gross physical damage to the casing, frame, or guards. All covers and guards appeared to be in place and properly secured.

The main power cable and its connection to the workshop supply were observed to be in good condition. The external appearance of the control panel and HMI was also satisfactory, with no obvious damage to buttons or the screen, and no unusual fault indicator lights were illuminated during the observed fault conditions.

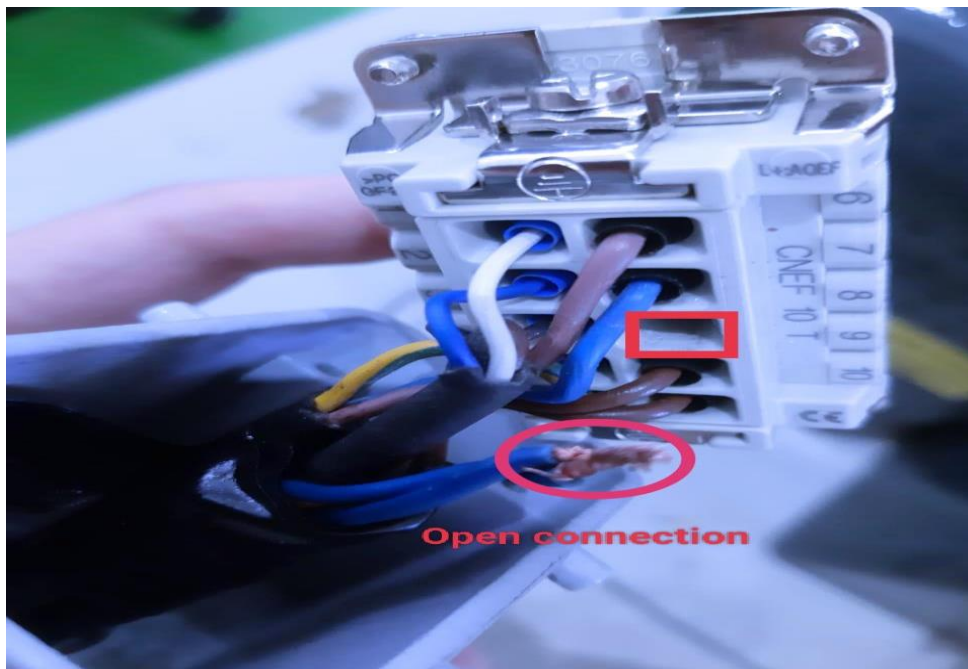
Figure 3. 2: The connector and the dislodged wire

*A critical observation: the multi-pin connector linking the control panel to the motor's control enclosure found faulty. Specifically, one wire within this connector was dislodged from its terminal, resulting in an open connection.*

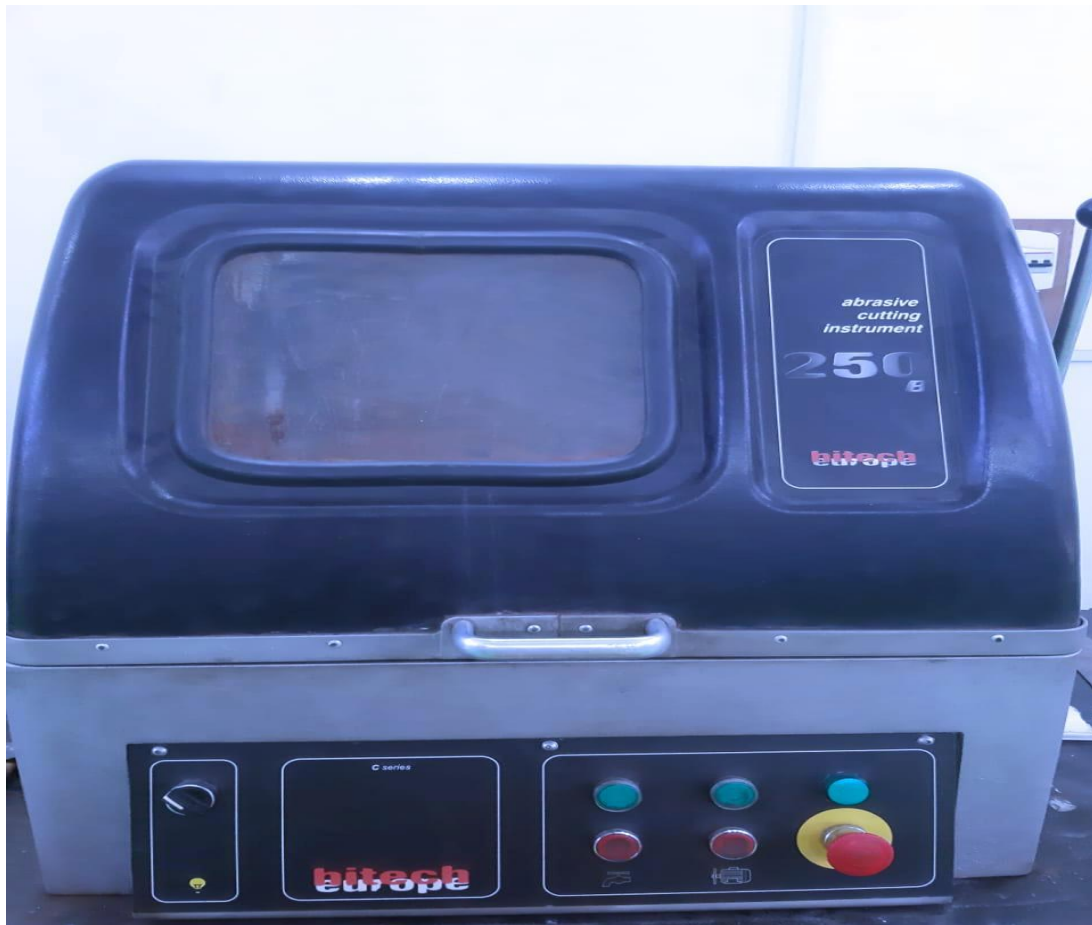
Figure 3. 3: The Hitech Europe 250 B Macro Cut-Off Saw

The investigation of Machine B was prompted by reports from workshop personnel indicating an abrupt shutdown during a sample cutting operation. Upon attempting to restart the machine, it was found that pressing the '**Motor On**' button failed to start the main drive motor. However, it was noted that the coolant system could be activated independently and was functioning normally when its respective button was pressed. This selective failure pointed towards an issue primarily affecting the motor, its main power or control circuit.

A visual examination confirmed the integrity of the machine's main power cable, its plug, and all externally visible wiring to the motor and coolant pump; there were no signs of damage. The control panel and its constituent buttons are physically intact, with no evidence of overheating, arcing, or other damage. The external casing of the main motor appeared free from immediate defects. Furthermore, the manual cutting wheel feed handle could be operated smoothly through its full range of motion, no apparent mechanical jamming of the feed mechanism.

During attempts to activate the main motor via its 'On' button, no discernible sounds (such as contactor clicks or motor humming) were produced. Similarly, no unusual smells indicative of electrical burning or overheating were detected from the control panel, motor, or associated wiring.

*An accumulation of cutting debris and coolant residue. A notable observation was that an abrasive cutting wheel was not installed on the machine at the time of inspection.*

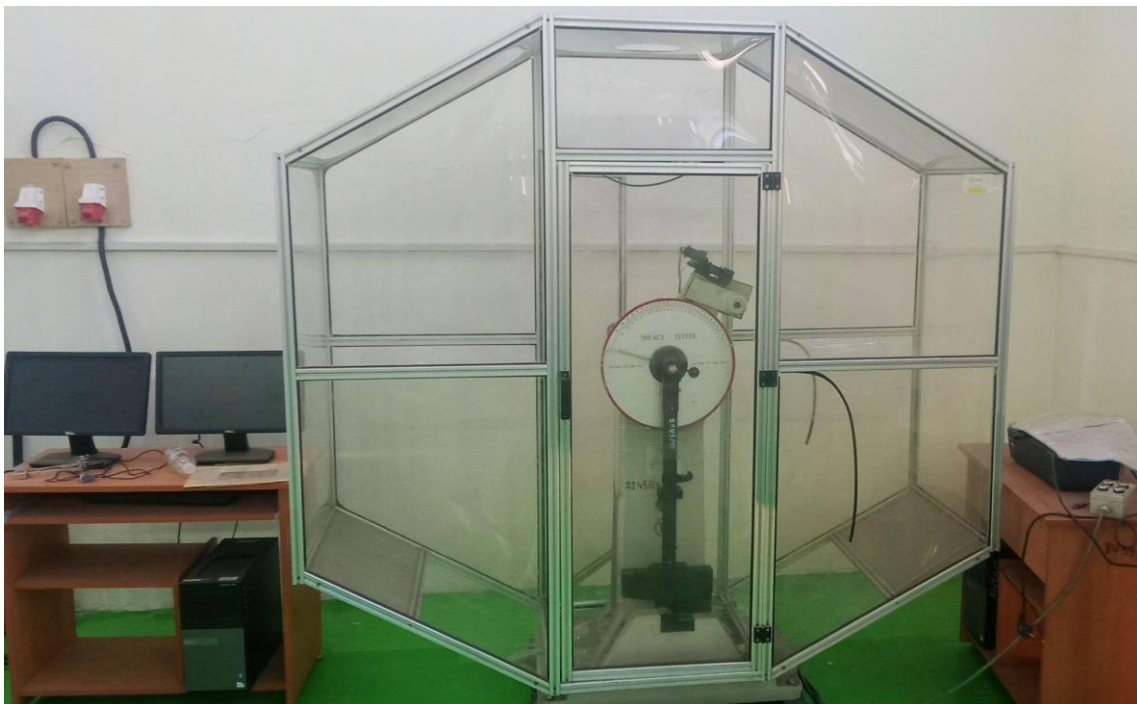
Figure 3. 4: The Impact Testing Machine (JBW-300N)

The diagnostic investigation for Machine C was initiated due to a severe electrical fault: the main workshop circuit breaker was reported to trip instantaneously whenever the machine's main power cable was connected to the electrical supply. which indicates a major fault condition, such as a direct short circuit or a very significant overload, within the impact testing machine.

A visual inspection of the machine's main power cable was conducted. This included an internal check of its plug/connector, where the wire terminations were confirmed to be secure after re-tightening. The cable itself showed no signs of external damage, cuts, or abrasions. The workshop-side power supply socket also appeared intact.

To further isolate the fault, the main power switch on the JBW-300N machine itself was turned to the '**OFF**' position. The machine's power cable was then reconnected to the workshop supply. Under this condition, the main workshop circuit breaker did not trip. This observation strongly suggested that the fault was located within the machine, downstream of its main power switch, rather than in the power cable or its immediate connection.

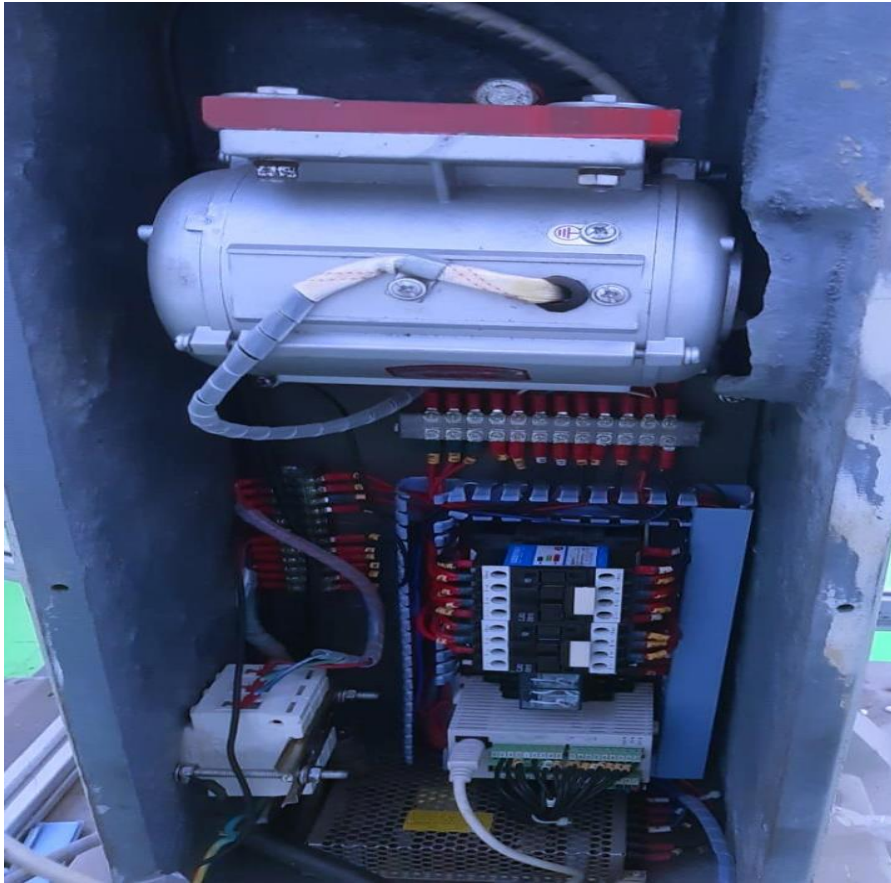
Figure 3. 5: Electrical Control Panel and Motor Assembly within the JBW-300N Impact Testing Machine.

there are no physical damage, arcing, or overheating. No unusual odors were detected.

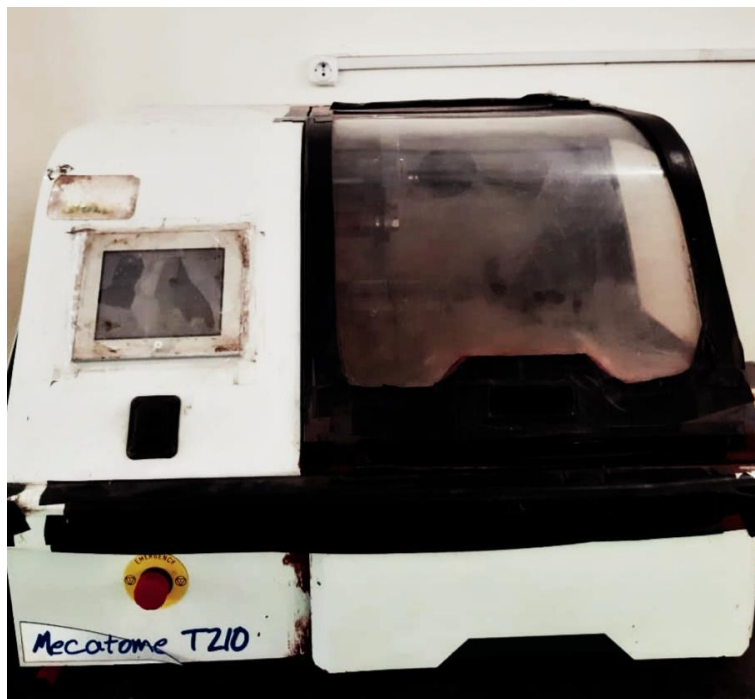
Figure 3. 6 : Micro Cut-Off Saw (Presi SA Mécatome T210)

Machine D is a precision micro-cutting saw (Mécatorme T210) used for fine sectioning of small samples ( $\leq 55$  mm) before microscopic analysis. Its a Monophase ( 230V), 1.5 kW variable-speed motor (300–6000 rpm) drives a 200 mm blade, and a six-nozzle coolant system prevents thermal damage. Operation modes include manual, automatic, and programmable, with a motorized X-axis for serial cuts. Swappable stainless-steel pallets accommodate diverse sample geometries in research and teaching settings [8].

The diagnostic process for Machine D was initiated due to a clear operational failure: the main cutting motor would not turn when commanded via the Human-Machine Interface (HMI). Attempts to alter operational parameters, such as cutting speed, through the HMI yielded no response from the motor. This indicated a fault preventing the motor drive system from engaging.

An external visual inspection of the machine, its power cable, control panel, and accessible wiring did not reveal any immediate signs of physical damage, loose connections, or overheating that could explain the fault. No unusual sounds or odors were present.

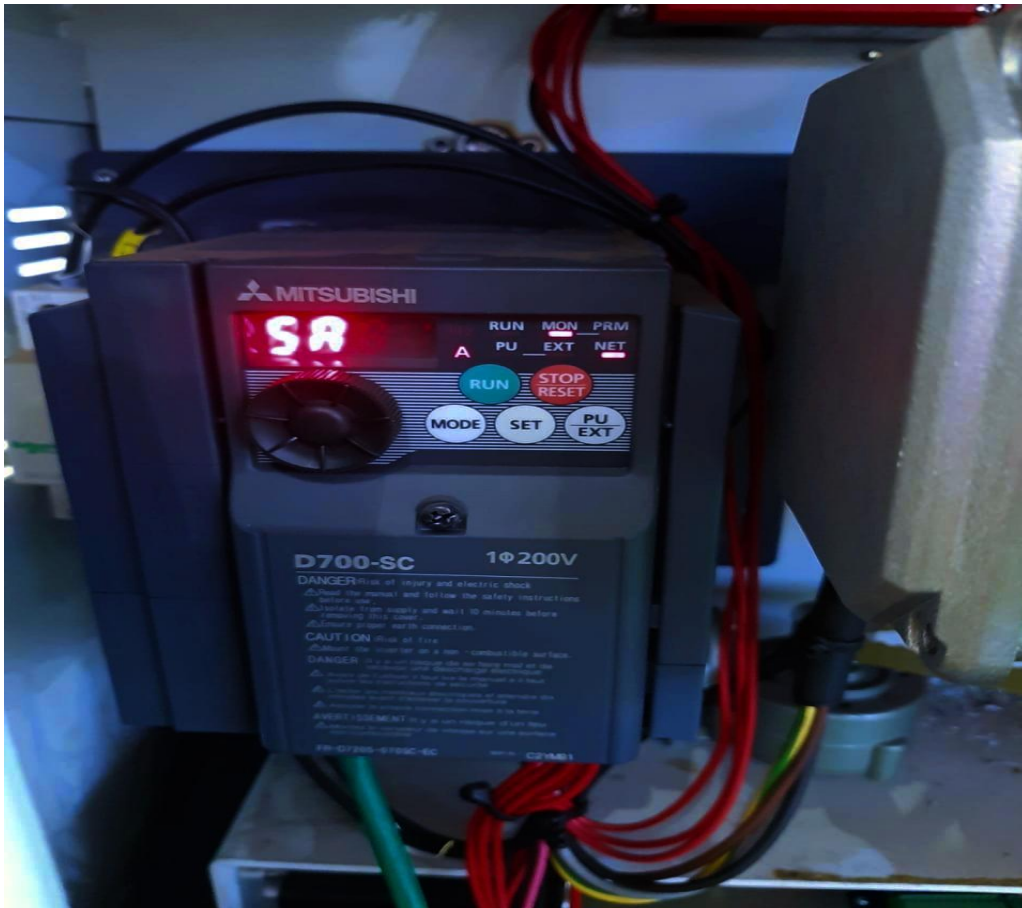
Figure 3.7: the drive display shows the "SA" error code

Upon obtaining authorization and following appropriate safety procedures to access the machine's internal components, the variable frequency drive (VFD) or motor drive unit was inspected. It was observed that the drive's display indicated "0 Hz" (zero frequency output) and subsequently showed an error code "SA."

Consultation of the drive's technical manual revealed that the "SA" error code signifies a "Safety Stop" condition. This code indicates that a safety input to the drive is active (or perceived as active), preventing the drive from outputting power to the motor. The manual specifically recommended checking the wiring of safety input terminals, often designated as S1, S2, or PC [10] particularly if the dedicated safety stop function connected to these terminals was not intentionally being used or had malfunctioned.

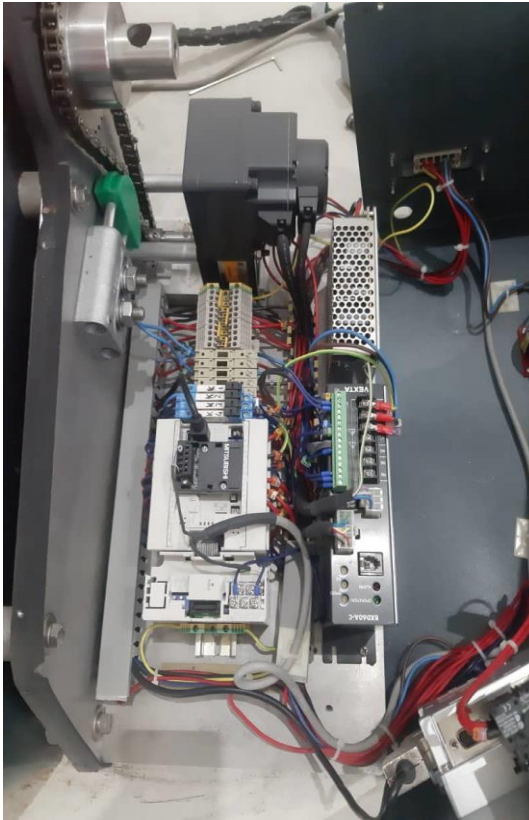
Figure 4. 1: The control unit components

These figures represent the control unit components and scheme wish is mainly defected.

Diagnostic Step & Action	Key Observation(s)	Conclusion(s)
<b>1. Connector Pin Repair</b>	Pin re-seated in previously identified damaged connector.	<ul style="list-style-type: none"> <li>● Motor no longer shut down prematurely.</li> <li>● positioning commands remained unresponsive. Further faults suspected.</li> </ul>
<b>2. Control Unit Inspection</b>	Checked continuity of Motor Position Sensors via manual actuation & manual Command Mechanism (for positioning).	<ul style="list-style-type: none"> <li>● Motor Position Sensors: Intact</li> <li>● Command Mechanism: No continuity; component damaged.</li> </ul>
<b>3. Control System drive</b>	<p>-CPU lamps indicate when executing positioning orders.</p> <p>-DC motor works when supplying it separately.</p> <p>-Drive Input: 232.5V AC; - Drive Output: 0V DC.</p>	<ul style="list-style-type: none"> <li>● Control system drive unit identified as failed (correct input, no output).</li> </ul>

1. A **failed control system drive unit** (0V DC output).
2. A **damaged manual command mechanism** for positioning .

1. More advanced examination on the faulty control system drive unit.
2. Repair or replace the damaged manual command mechanism.

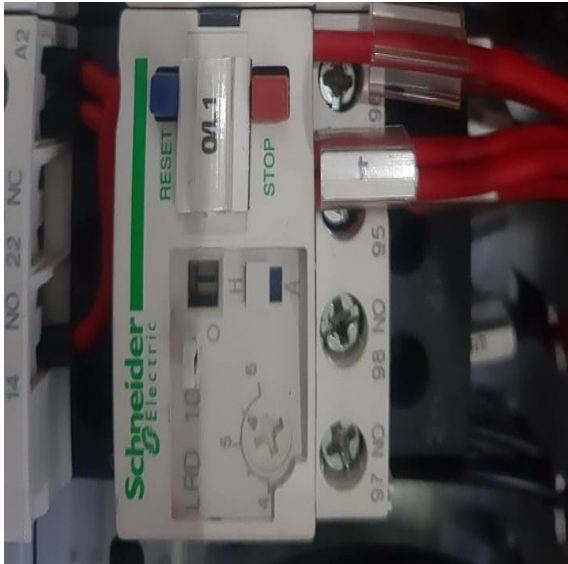
Figure 4. 3: The motor overload relay

- 1- The failure of the motor to start was caused by a tripped motor thermal overload relay.
- 2- The subsequent failure of the motor to brake effectively was caused by a maladjusted mechanical braking disc .

- 1- **Motor Overload:** The motor overload relay was **reset**.
- 2- **Mechanical Brake:** The loose bolts on the mechanical braking disc assembly were tightened to restore proper engagement. and **the braking system back to be functioning correctly**.

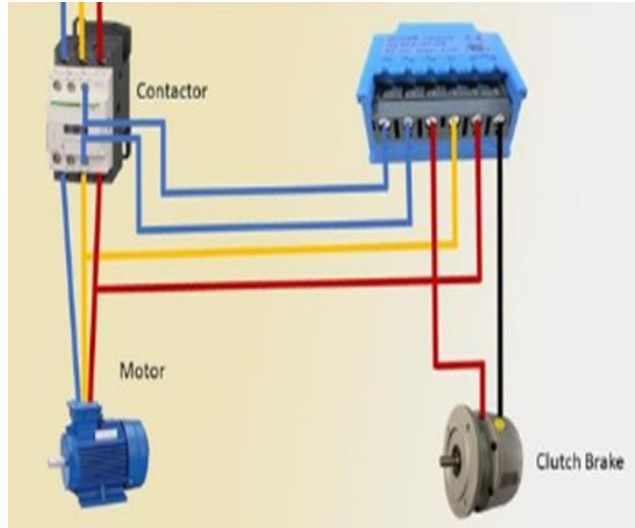
Figure 4. 4: A representation of the braking system circuit

<b>4. Mechanical Brake Inspection</b>	- Inspected the mechanical braking disc assembly. its not reacting to orders.	<ul style="list-style-type: none"> <li>● The braking disc mechanism was found to be non-operational</li> </ul>

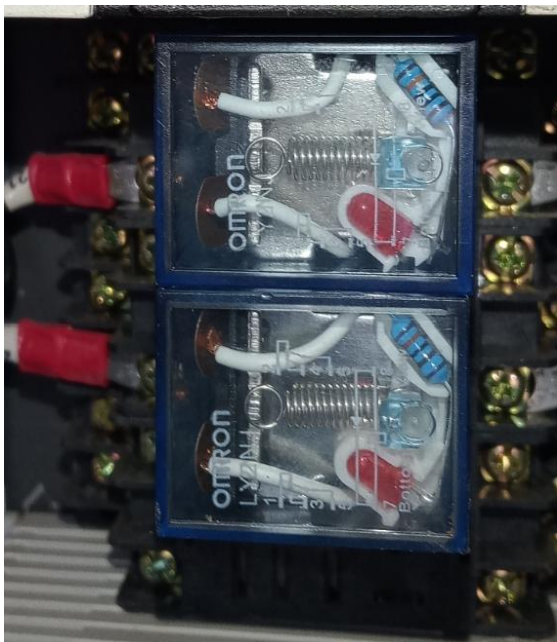
Figure 4. 5: The protection relays

Diagnostic Step & Action	Key Observation(s)	Conclusion(s)
<b>1. Internal Control unity Inspection</b>	- A wiring issue was identified: a direct connection between a neutral conductor and the equipment ground.	<ul style="list-style-type: none"> <li>• An immediate correction to the wiring is a necessary.</li> </ul>
<b>2. Correction of Wiring Fault</b>	-The incorrect wiring (neutral-to-ground short) was rectified and when re-powered up the main circuit breaker no longer tripped.	<ul style="list-style-type: none"> <li>• The immediate short circuit fault was resolved.</li> </ul>
<b>3. Pendulum Control Functionality Test</b>	-Release and impact pendulum functions are not executing..	<ul style="list-style-type: none"> <li>• A circuit control fault or electrovalve damaged.</li> </ul>
<b>4. Pendulum Lift &amp; Release Circuit Examination</b>	- When bypassing the relay , the system run correctly.	<ul style="list-style-type: none"> <li>• Relay’s power supply is faulty.</li> </ul>

- 1- The primary cause of the workshop circuit breaker tripping was a **direct short circuit** between a neutral conductor and the equipment ground within the machine's control unit.
- 2- The failure of the pendulum to respond to Impact and release commands was traced to issues to **the control relay circuit** .

- 1- Neutral-Ground Short: The issue was permanently corrected by separating the conductors and ensuring proper termination.
- 2- Pendulum Control Relays:
  - Implemented Action (based on bypass test): The successful operation via bypass confirmed the downstream actuators were likely functional.
  - Recommendation: Conduct an advanced examination of the suspected control relays .

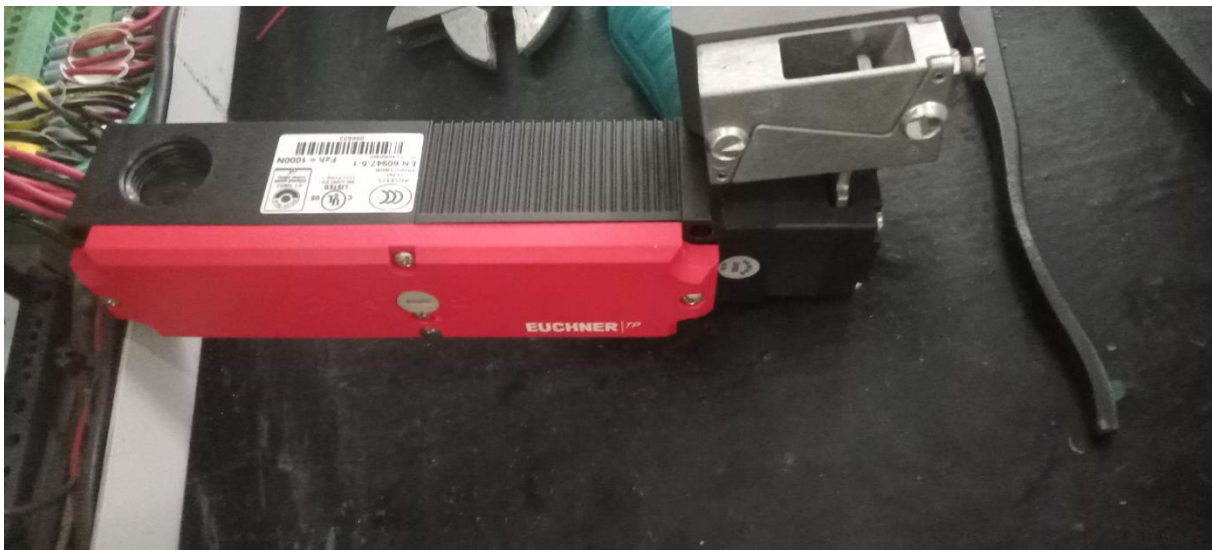
Figure 4. 8: The safety relay module and its mechanical actuator.

The detailed examination focused on the motor drive's safety circuit and associated components,

<b>Diagnostic Step &amp; Action</b>	<b>Key Observation(s)</b>	<b>Conclusion(s)</b>
<b>1. Drive Safety Input Terminal Check</b>	-After jumpering drive's safety input terminals S1, S2, and PC as indicated by the drive manual[10] , the motor run correctly	<ul style="list-style-type: none"> <li>● The motor and drive are intact.</li> <li>● inspection to the safety relay module is necessary.</li> </ul>
<b>2. Inspection of External Safety Circuit</b>	-The insulation on the wiring was found to be in a critical, damaged condition.	<ul style="list-style-type: none"> <li>● A necessary correction to the wiring insulation .</li> </ul>
<b>4. Door Safety relay and Mechanism Examination</b>	-The door's mechanical actuating mechanism for the safety relay was found to be misaligned	<ul style="list-style-type: none"> <li>● A Mechanical Issue is preventing proper relay engagement even if the wiring was intact.</li> </ul>

The indication "SA" (Safety Stop) error on the motor drive was due to a malfunctioning door safety interlock circuit. This malfunction was caused by a combination of:

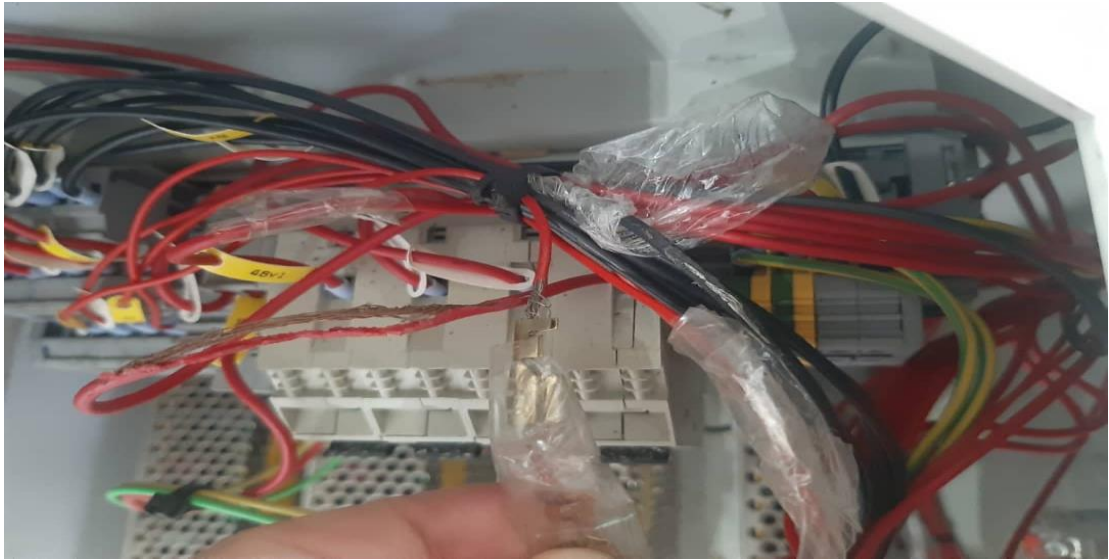
Figure 4. 9: The wiring before correcting its insulation.

1- **Damaged wiring insulation** for the safety relay module.

1- **For the Wiring:** The damaged insulation wiring was repaired.
